Innovative Aeration Retrofit of Existing Failed Septic Systems Around Lake Livingston, Texas - A Case Study

Terrell R. Hoage, Ph.D. Department of Biological Sciences, Sam Houston State University, Huntsville, TX. 77341

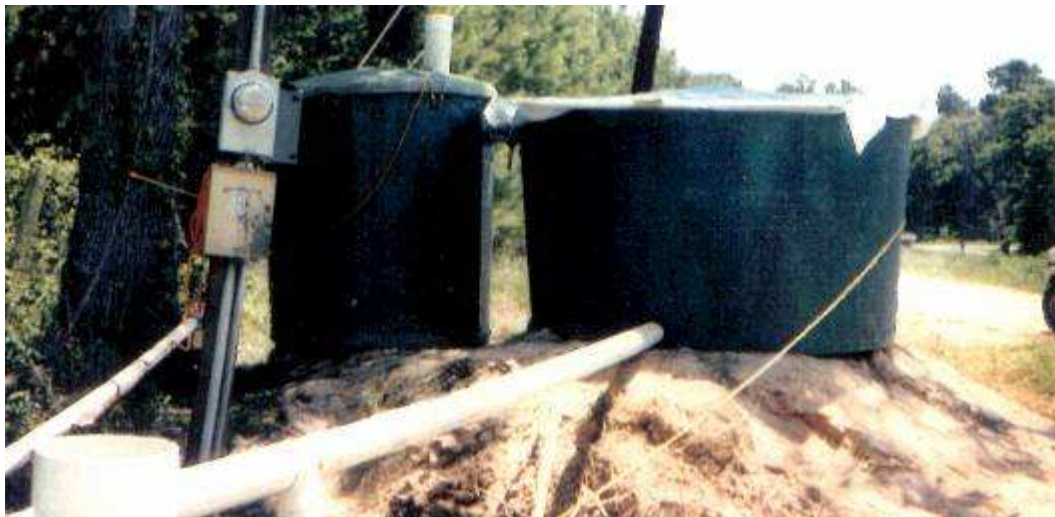
A second experiment (Figure 1) was set up using a single 500 gallon fiberglass tank with a baffle separating one third of the waste mass just in front of the effluent tee. An aerator was

placed in front of the baffle and 300 gallons per day of raw sewerage from the Texas Landing Development (Hoage et al, 1993) was pumped from the wet well into the tank each day. The effluent was directed into a 30 square feet free access sand filter which was designed to handle 10 gallons of aerated waste water per square foot of surface area. In this arrangement, the filtered waste water was tested for BOD, TSS, DO, Coliform, and Ammonia/Nitrites. In this test the BOD was reduced by 90%, TSS reduced by 85%, Coliform reduced by 96% and the DO in the filtered water averaged 5.2ppm. Tests were conducted by Eastex Environmental Labs according to the EPA Standard Manual.

Figure 1. Tank test system using vacuum microbubble aeration pretreatment at Texas Landing on Lake Livingston.

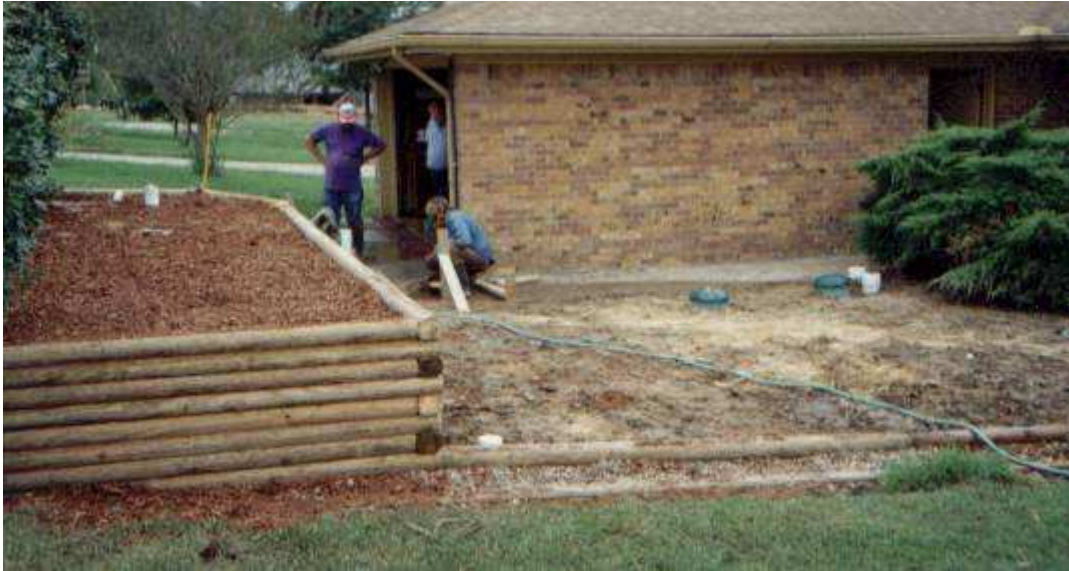
A third test conducted at Texas Landing produced the same level of reduction as measured previously. After these results were analyzed, TRA approved the installation of this innovation in the Bob Nelson property (Hoage et al, 1993, Figure 2) which had a failed system with reduced absorption area that was occluded with solid wastes. Septic Hydro-Tec flushed the field lines using bacterial digestion and restored the absorption field. The innovative design stipulated an aerator in the first of two septic tanks with a modified clarifier and filter designed to retain suspended solids for digestion. The second tank was fitted with a submersible pump that lifted the water to a holding tank that regulated water flow into a free access sand filter designed to

landscape specifications. The water from the sand filter was then routed into the cleaned field lines. After one year of operation, there has been no odor, no line obstruction, no overflow into the holding tank, and no field absorption problems even after heavy holiday and summer occupation. A 30" rain in October of 1994 failed to affect this or any of the aeration systems installed.

Figure 2. System design for the Bob Nelson residence on Lake Livingston.

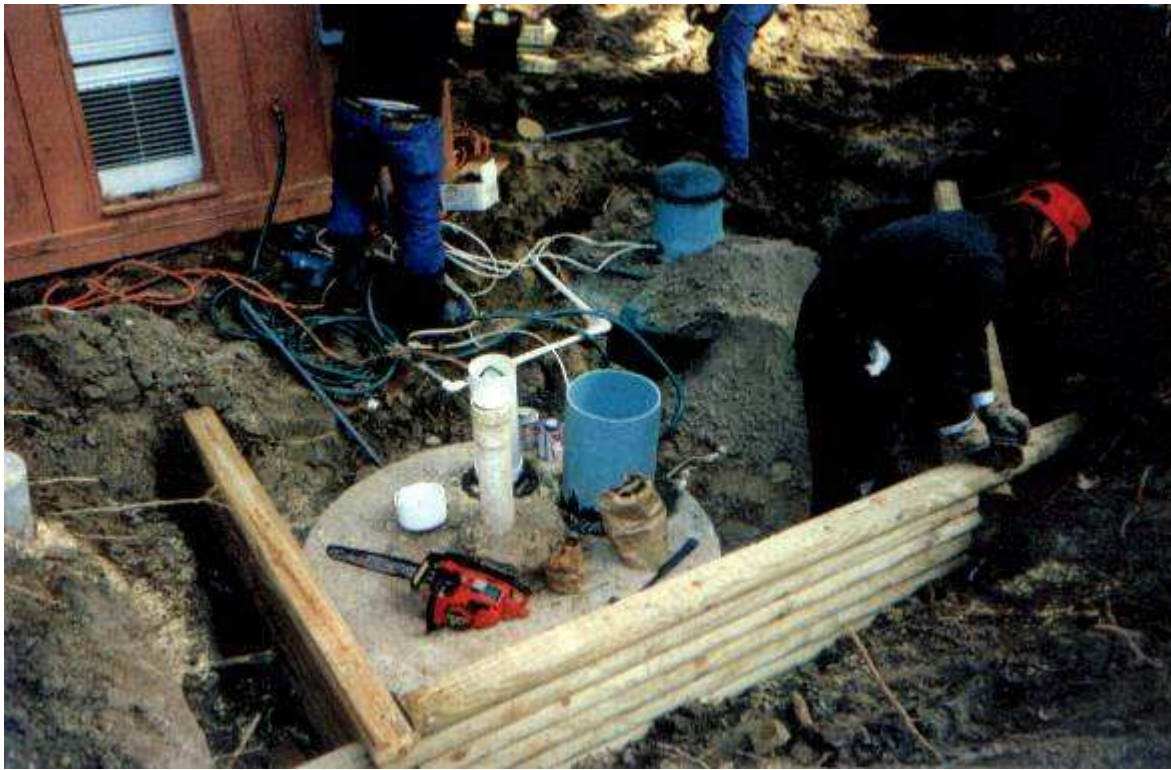
Another innovative system was designed to handle field flow problems at the Roy Walker (Figure 3) site which required cleansing of the field lines and the installation of a new underground self-cleaning emitter system (Figure 4). This too, required landscaping design to fit the space and terrain on a small lakeside lot.

Figure 3. Innovative design for the Roy Walker site that corrected a 100% failed field and tank system using the existing tanks.

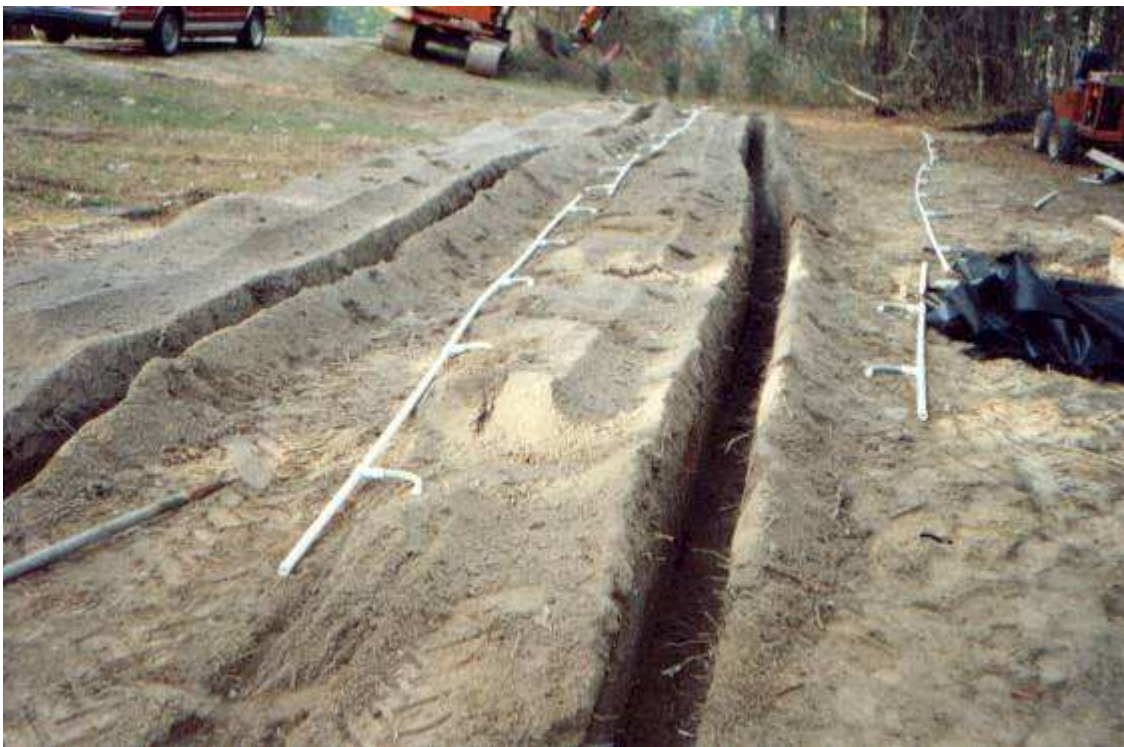
Figure 4. Examples of underground emitters placed in a 10" trench and filled with chopped rubber and covered with 100 mesh groundcloth

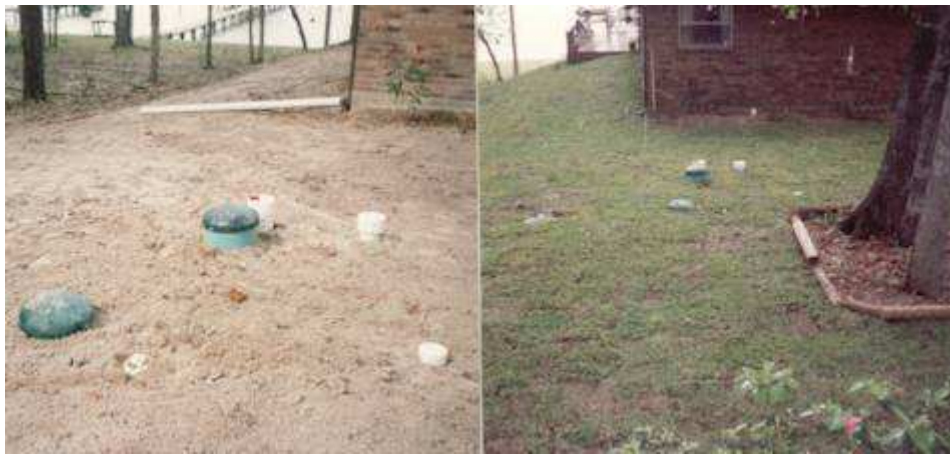
The David Cartier lake lot (Figure 5) was another reduced lot size requiring landscaping and the use of aeration and added emitter lines to correct the dosing problem for the limited land space. By the addition of self cleaning emitters and clean aerated wastewater, the field absorption area was efficiently used.

Figure 5. Corrective applications to the existing tank system of the Cartier site.

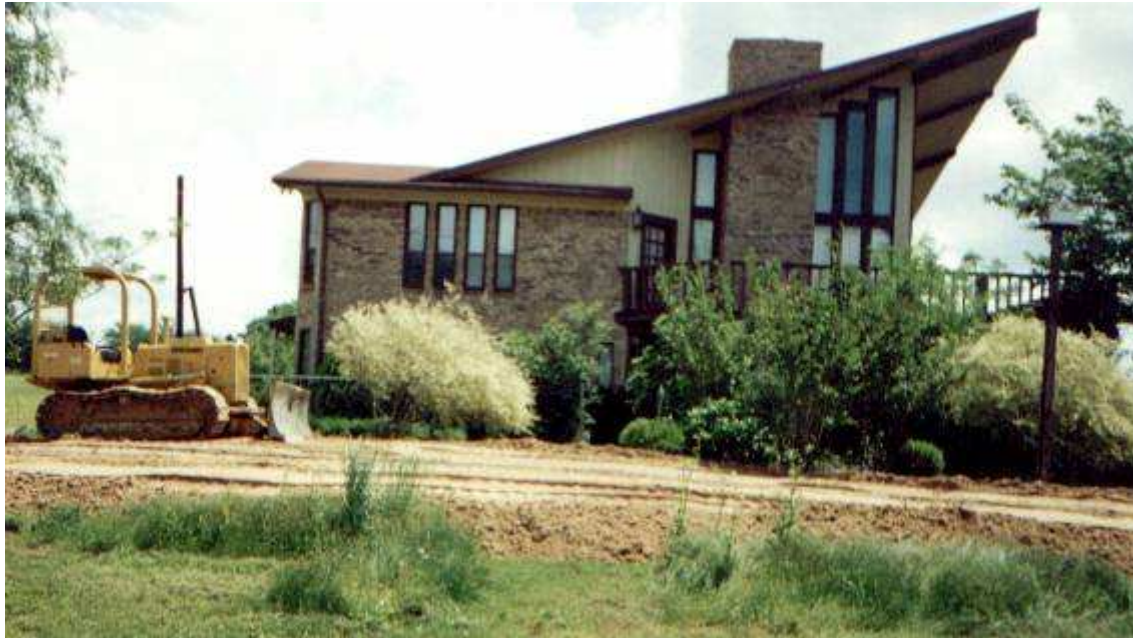
Clay absorption areas presented a real challenge to the Chuck Hogue lake lot (Figure 6) runoff problem. To remove the solids that readily obstructed the field lines an aerator was again positioned in the first of the existing tanks and the remaining tanks were converted to clarifier and pump tanks for dosing the water where it was most useful. Since the house was situated on a clay bank, it was suffering from severe foundation problems due to the wet-dry cycle that produced swelling and shrinkage in the clay. These forces had cracked the foundation and

caused cracks in the brick veneer of the two story house. Emitters were placed around the house such that the clay would retain a constant moisture level and alleviate the swelling-shrinking cycle. This water came from the aeration sand filter design previously designated and adapted to this situation.

Figure 6. Remediation of a 100% failed system at the Hogue site.

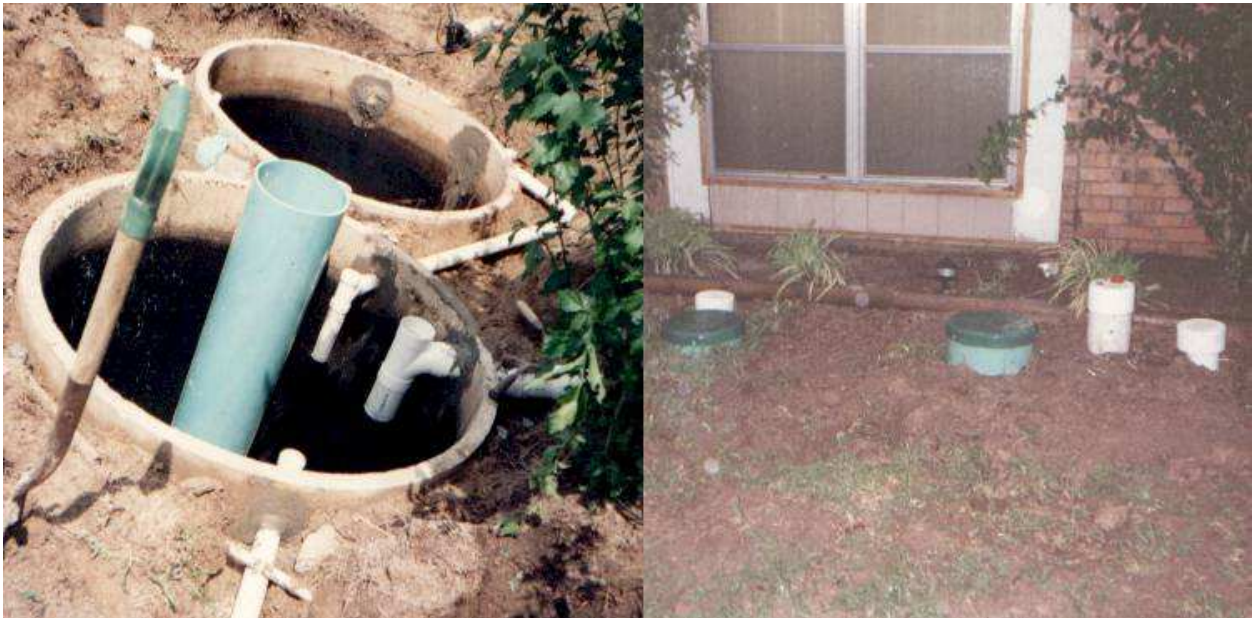
The Vick Koltys lake lot (Figure 7) presented a 20X35 foot working area with a 100% failed system. Both tanks were filled with sludge and the field lines were completely obstructed. The tanks were pumped and cleaned and the field lines were bacterially treated and flushed to restore flow to normal rates. An Aerob-A-Jet¹ aerator was installed in the first tank, a clarifier fitted to the effluent tee and a pump tank generated from the third tank. The system is 100% restored using the old tanks and lines.

Figure 7. Conversion of a holding tank system at the Kolyts site.
